## AVIATION INVESTIGATION REPORT

A00Q0046

### IN-FLIGHT BREAK-UP

**BELL 206B-III (HELICOPTER) C-GFSE**

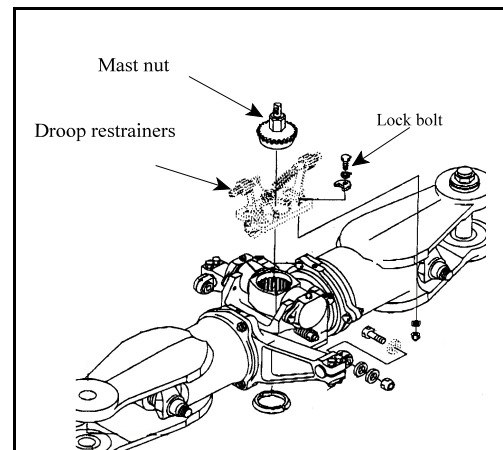
Figure 1 - Rotor head

Examination of the hub revealed that the mast nut, the droop restrainers, and the spacer that replaces the droop restrainers when they are not installed were all missing. The internal threads in the holes where the droop restrainers attach to the hub were intact, and the examination revealed no attachment bolt debris. Examination of the main-rotor mast and the head trunnion indicated that the damage was caused by a vertical movement of the hub. The two pitch control rods failed in overload. Shortly after the occurrence, the droop restrainers and the mast nut for C-GFSE were found in the S.C.G. Hélicoptère inc. hangar at the same location where they had been left the day before by the apprentice AME.

Examination of the rotor head and its components indicates that the main rotor separated from the aircraft because the mast nut was not in place. The possibility that another mast nut was installed before the take-off and came loose in flight was rejected because all the mast nuts in inventory were found in the S.C.G. Hélicoptère inc. hangar. Consequently, the aircraft took off with no mast nut.
